# STANDARD HOUSE INSPECTION

For the Property Located At:

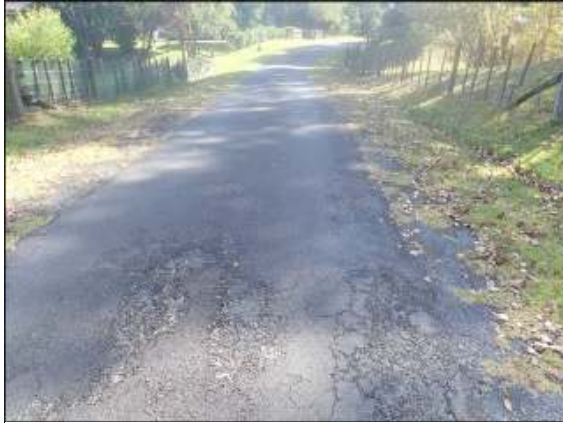
Concrete pavement from main street to driveway appeared in good condition.

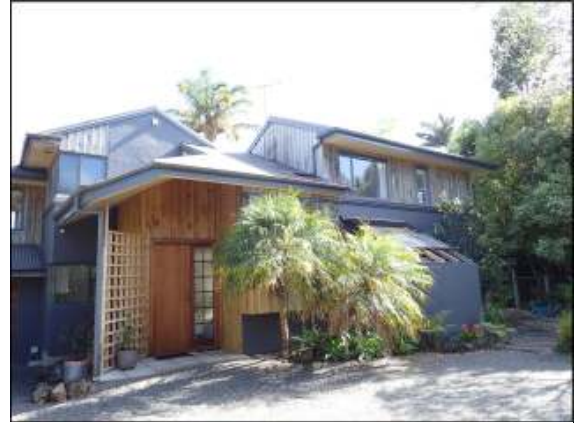
South main facade with metal joinery on exterior wall cladding appeared in good condition without damage noticed.

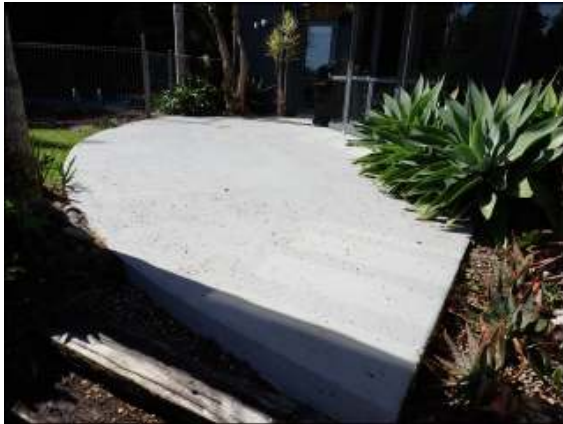
Concrete pavement porch appeared in good condition without crack or damage noticed.

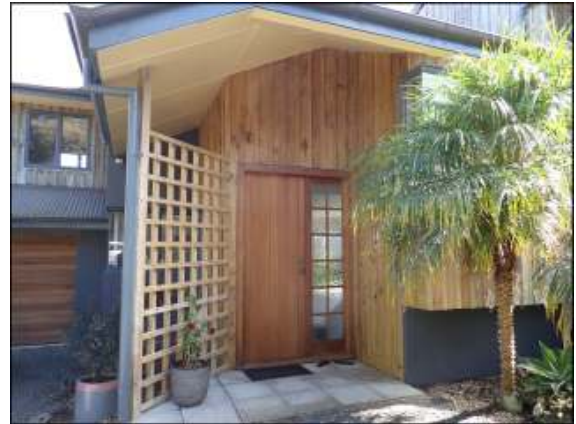
Main entrance door secured under covered walkway appeared in good condition.

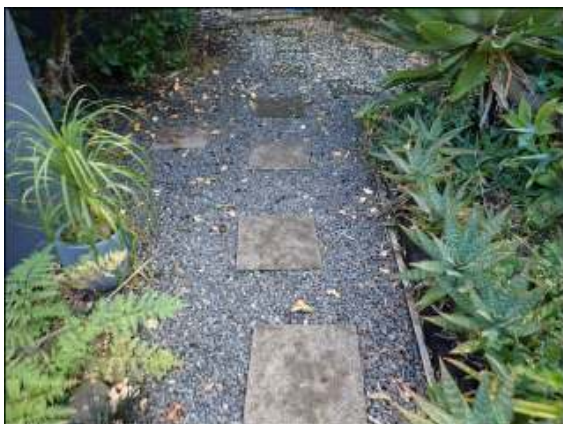
Landscape stone pavement foot path on pebbles appeared in good condition without crack or damage noticed.

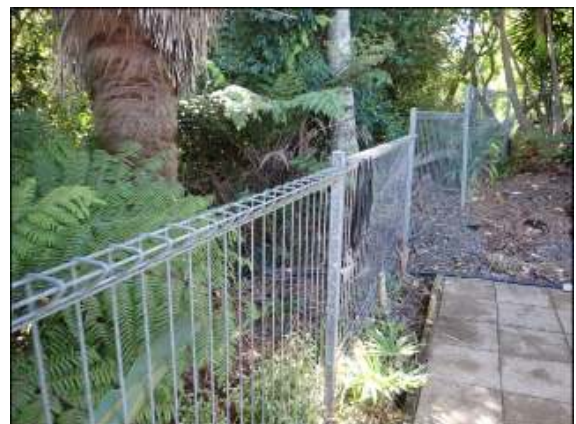
Metal fence appeared in good condition without damage or sign of out of verticality noticed.

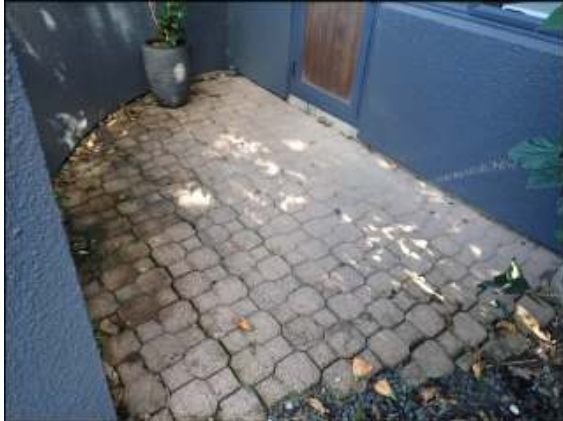
Landscape stone pavement porch appeared in good condition without crack or damage noticed.

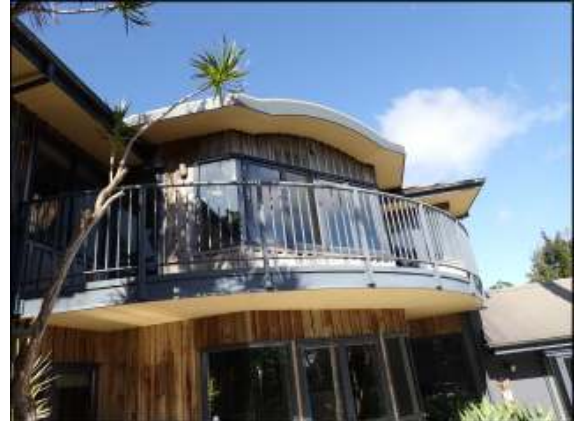
Cantilever balcony secured with guardrail appeared in good condition without damage or anomaly noticed.

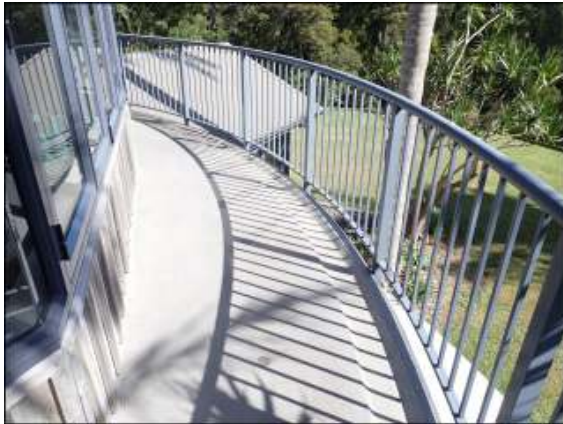
Membrane pavement balcony secured with guardrail appeared in good condition without damage or anomaly noticed.

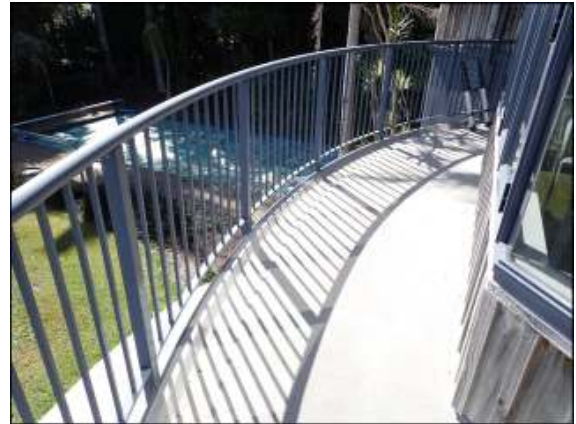
Membrane pavement balcony secured with guardrail appeared in good condition without damage or anomaly noticed.

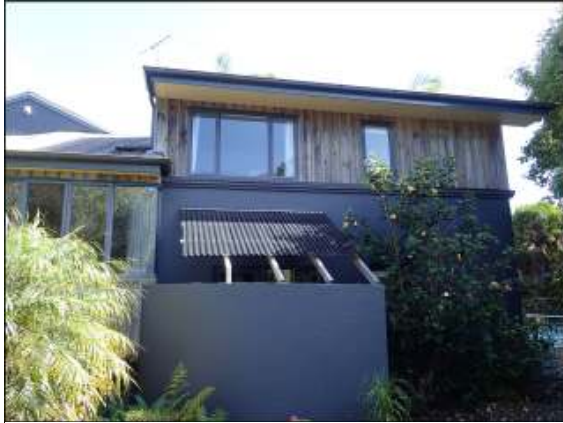
South facade with metal joinery on exterior wall cladding appeared in good condition without damage or anomaly noticed.

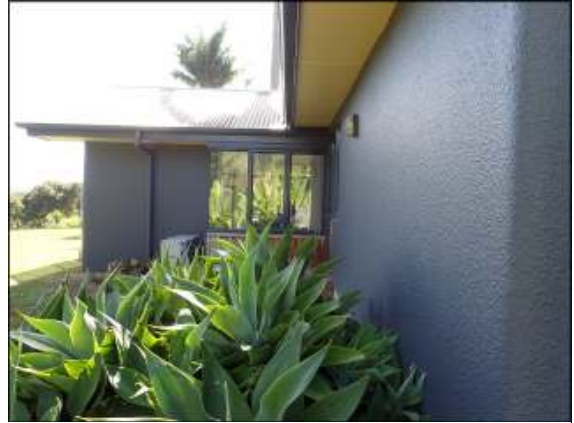
West facade with metal joinery on exterior wall cladding appeared in good condition without damage or anomaly noticed.

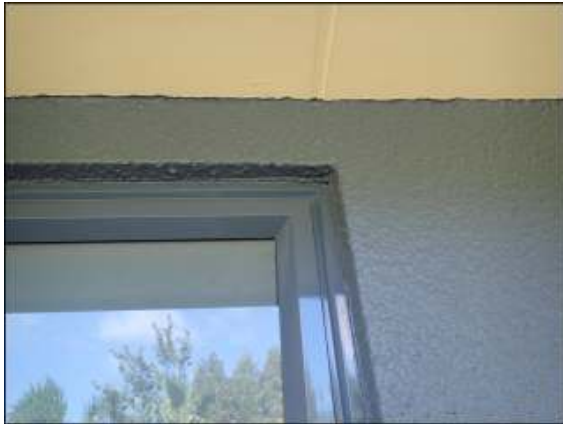
Metal joinery secured under eave appeared in good condition without damage or anomaly noticed.

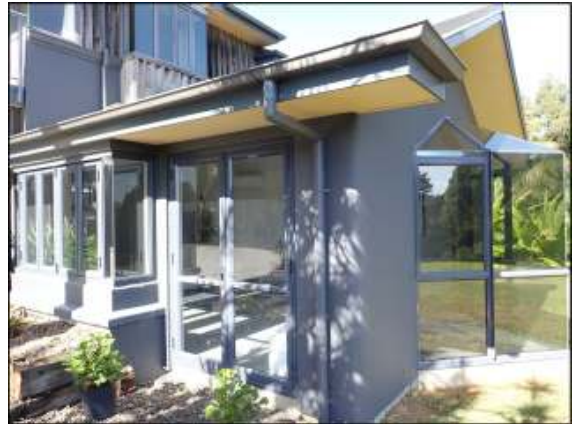
North East facade with metal joinery on exterior wall cladding appeared in good condition without damage or anomaly noticed.

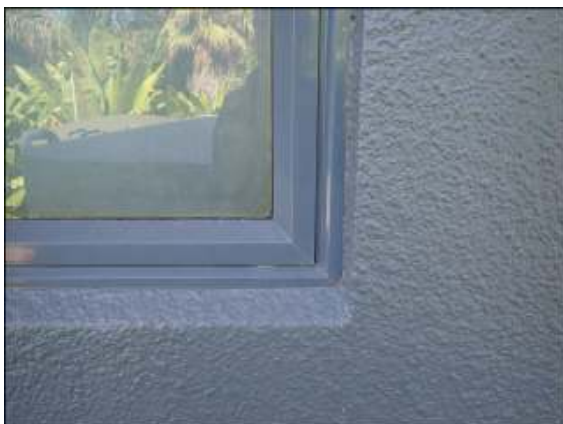
Metal joinery secured on sloped sill on exterior wall cladding appeared in good condition without damage or anomaly noticed.

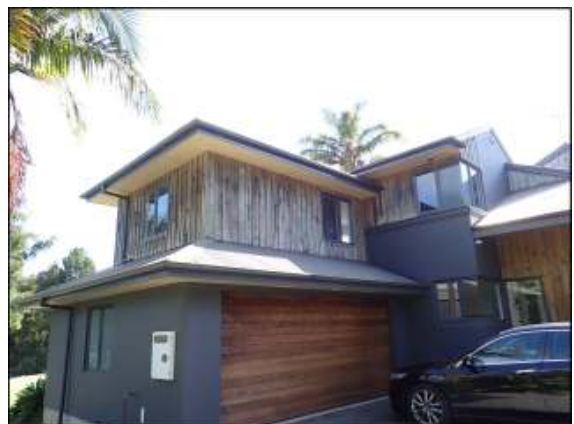
Metal joinery secured on exterior wall cladding appeared in good condition without damage or anomaly noticed.

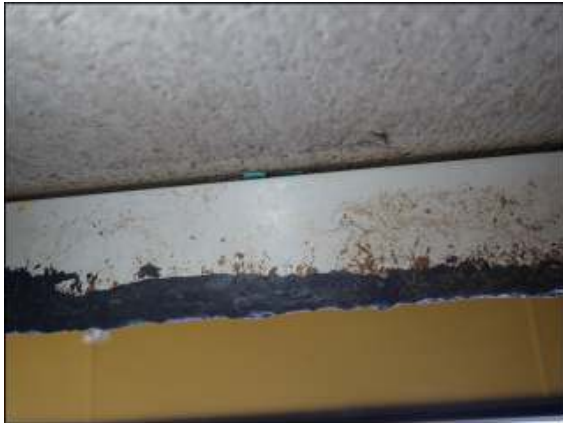
Under side of EIFS(Exterior Insulation & Finish System) exterior wall cladding appeared in good condition without damage or anomaly noticed.

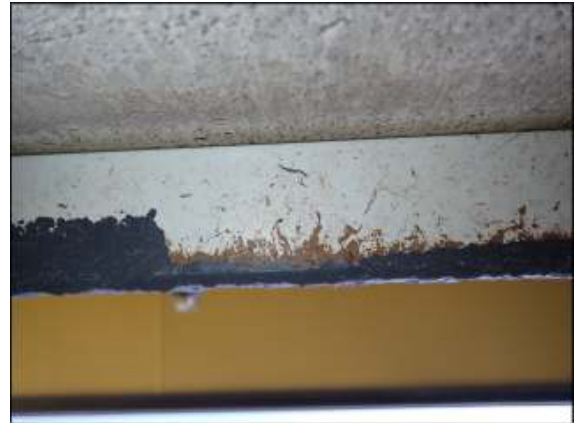
Under side of EIFS exterior wall cladding appeared in good condition without damage or anomaly noticed.

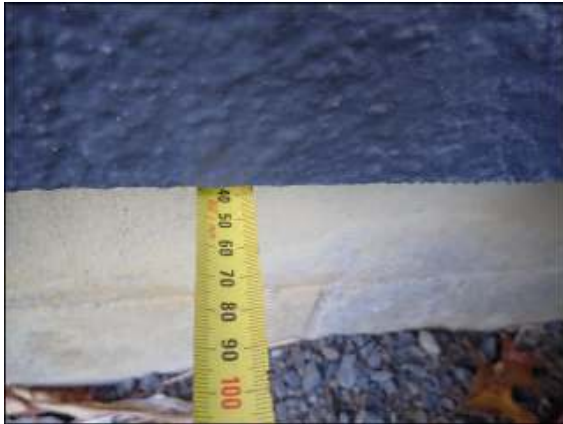
Bottom of of EIFS exterior wall cladding appeared in good condition without damage or anomaly noticed.

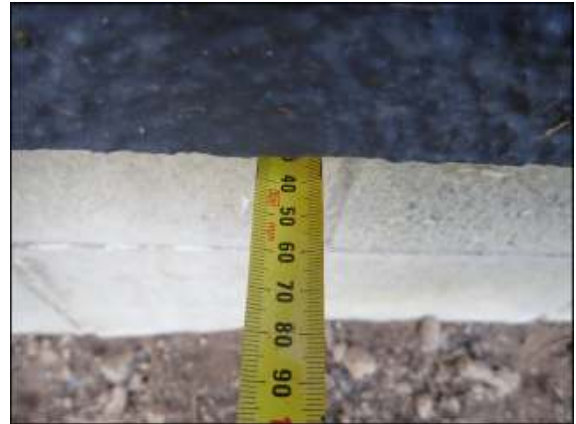
Bottom of of EIFS(Exterior Insulation & Finish System) exterior wall cladding appeared in good condition without damage or anomaly noticed.

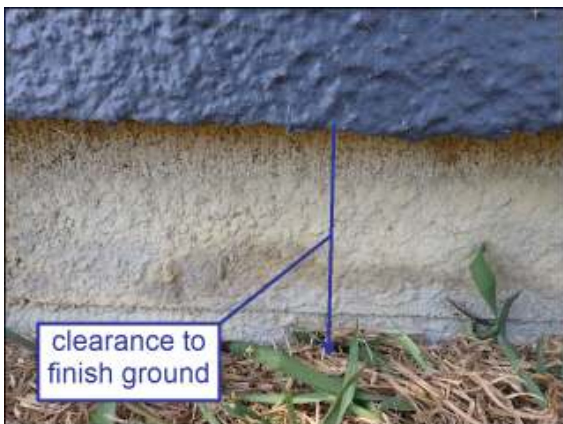
Bottom of of EIFS(Exterior Insulation & Finish System) exterior wall cladding cleared to finish ground appeared in good condition without damage or anomaly noticed.

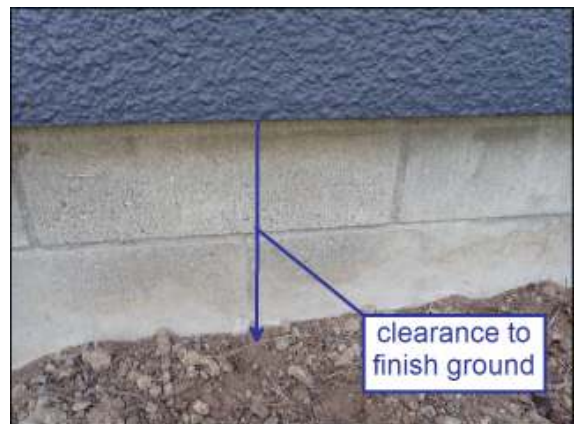
Bottom of of EIFS exterior wall cladding cleared to finish ground appeared in good condition without damage or anomaly noticed.

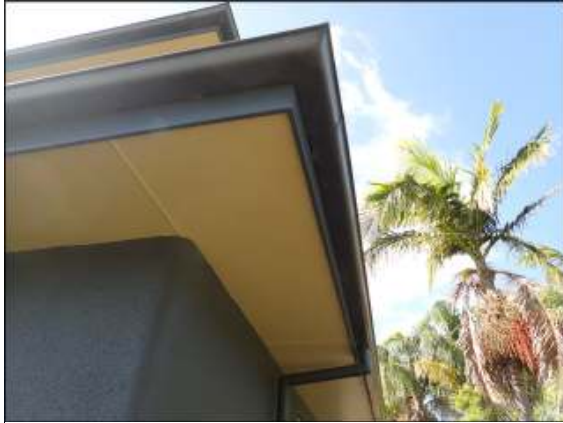
Metal gutter secured on barge board appeared in good condition without damage. Noticed internal guttering system installed.

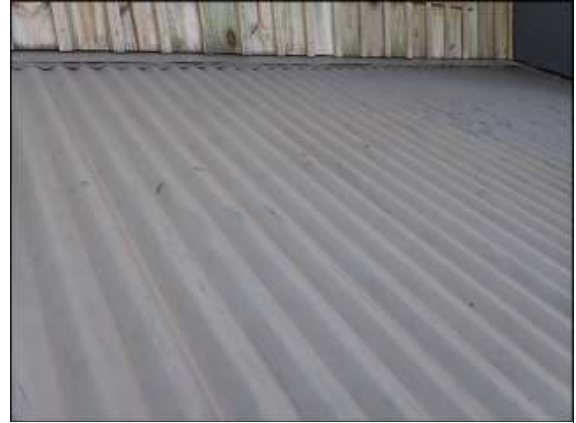
Maintained corrugated sheet metal roof appeared in good condition. No dent and/or damage noticed.

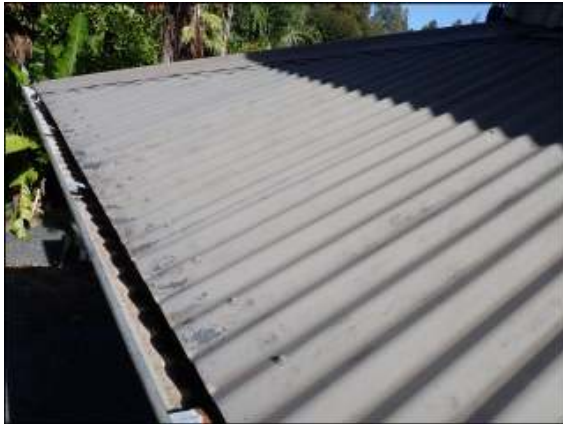
Maintained corrugated sheet metal roof appeared in good condition. No dent and/or damage noticed.

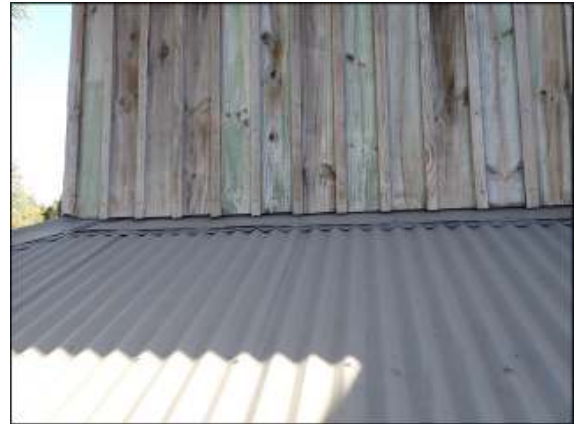
Exterior wall cladding cleared to finish roof, secured with metal flashing, appeared in good condition without damage or anomaly noticed.

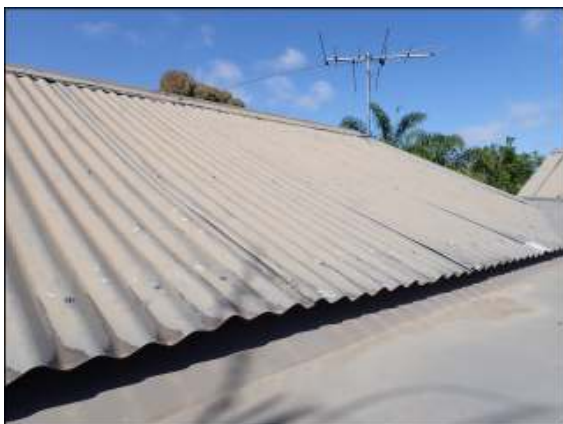
Corrugated sheet metal roof appeared in good condition at valley without damage noticed.

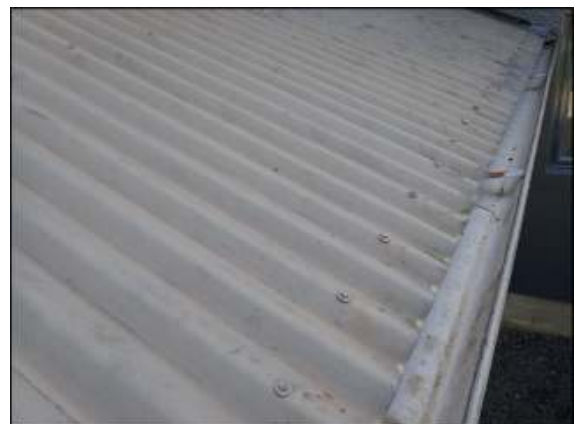
Maintained corrugated sheet metal roof appeared in good condition. No dent and/or damage noticed.

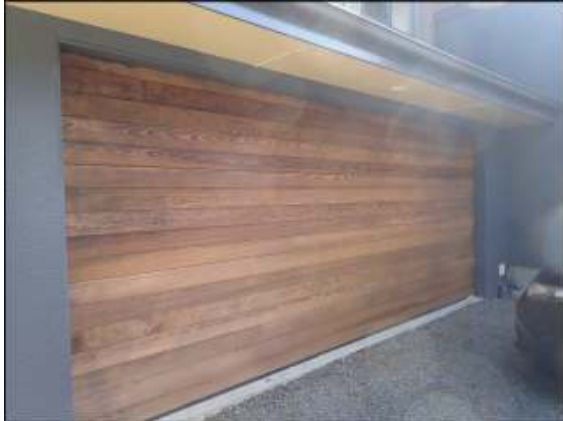
Timber overhead panel garage door outside appeared in good condition.

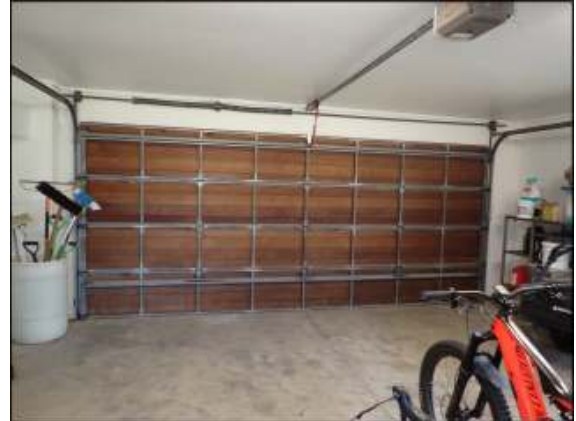
Timber overhead panel garage door inside appeared in good condition. Operation was tested and working normal.

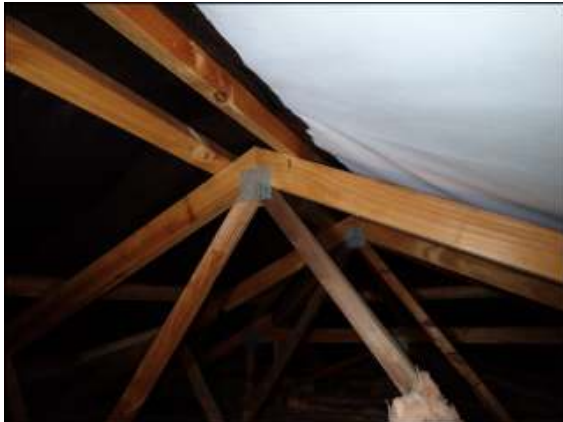
At attic(roof cavity), roofing paper secured on timber roof frame without trace of leaky evidence noticed.

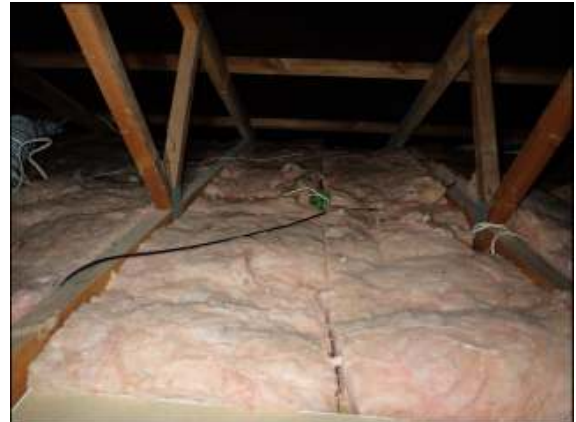
Roofing paper secured on timber roof frame. Fibreglass blanket insulation laid in with R-1.8 approximately.

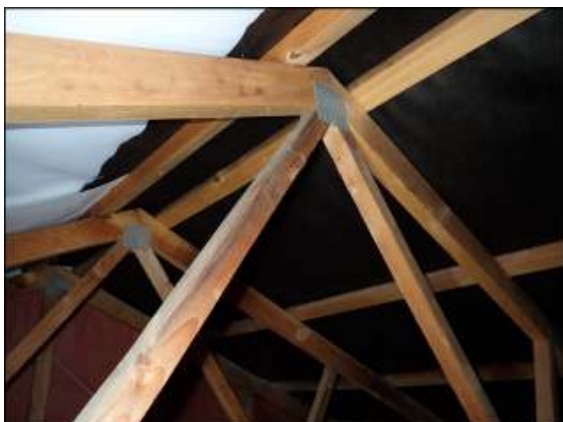
Roofing paper secured on timber roof frame without trace of leaky evidence noticed.

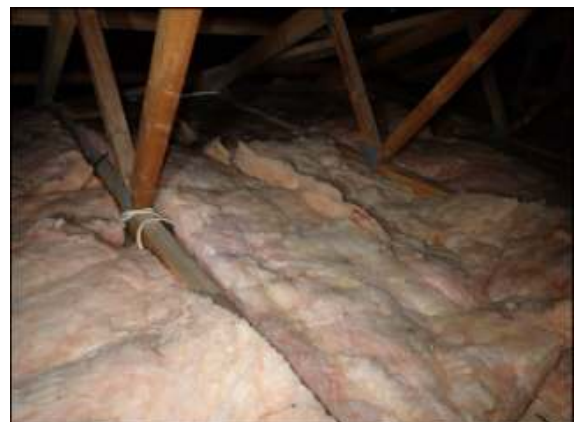
At attic(roof cavity), fibreglass blanket insulation laid in with R-1.8 approximately.

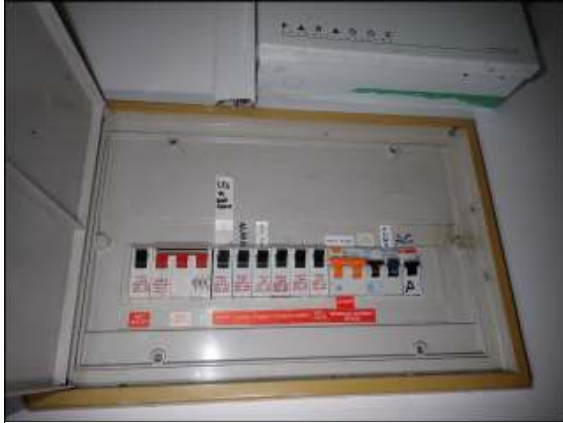
Electric power distributor and circuit breaker.  
No damage or risk factor noticed.

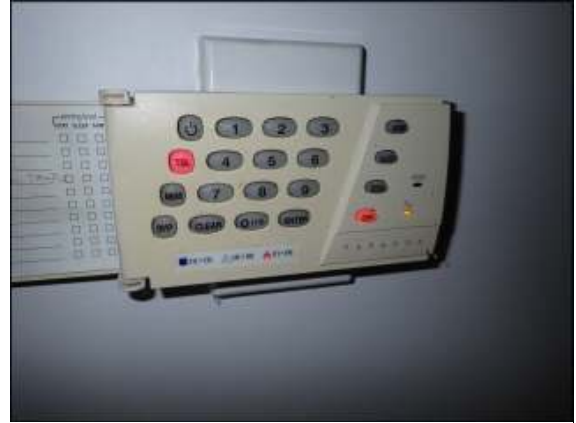
Home security control panel on interior wall.  
Operation was not tested.

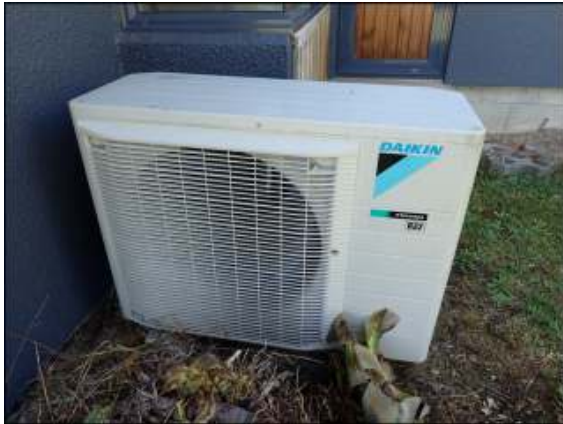
8.0 kW heating capacity heat pump generator  
on pad appeared in good condition. Operation  
was not tested.

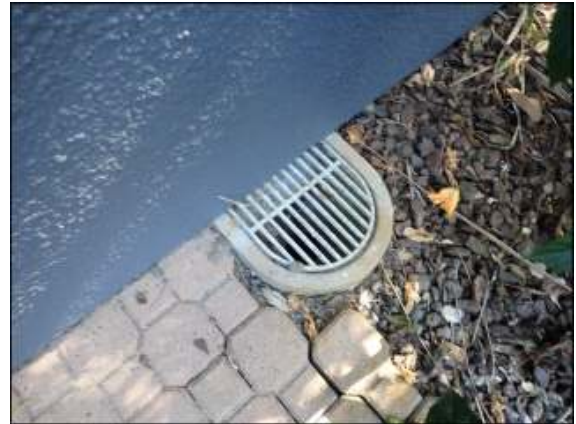
Raised with concrete gully trap secured with  
metal lid appeared in good condition.

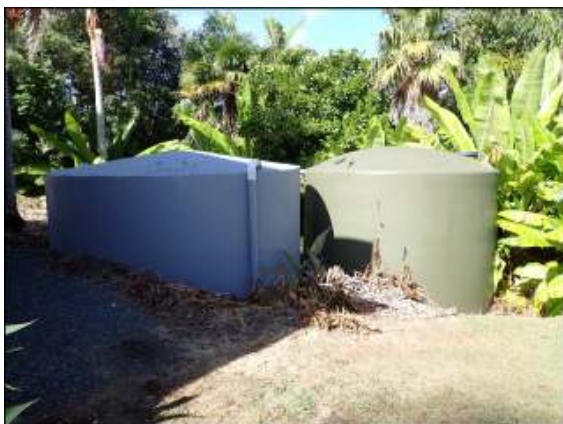
Rain water collecting tank secured on ground  
appeared in good condition. No damage or  
anomaly noticed

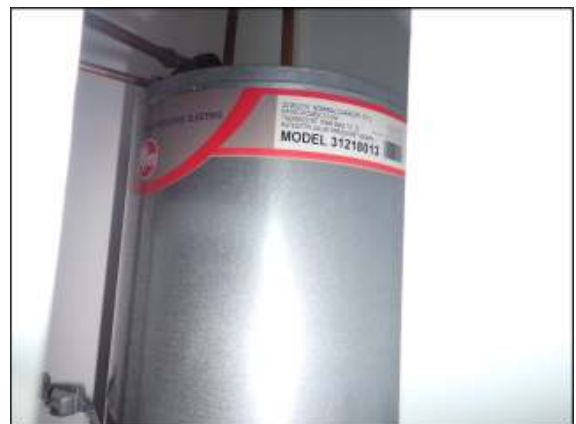
177 litre electric mains pressure hot water  
heater, manufactured in June 2016.

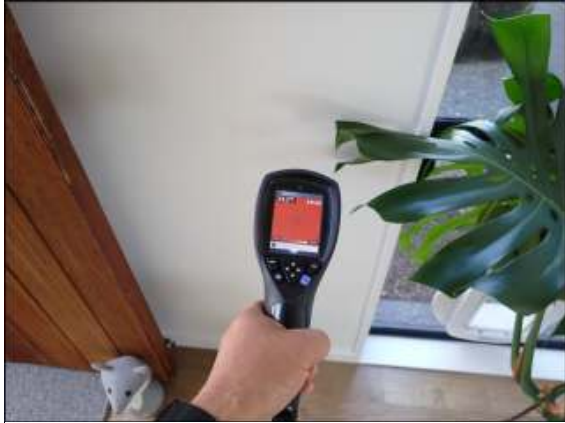
**Photo 25.1** Normal level of moisture reading detected with infrared thermal imaging camera on wall facing exterior at foyer area.

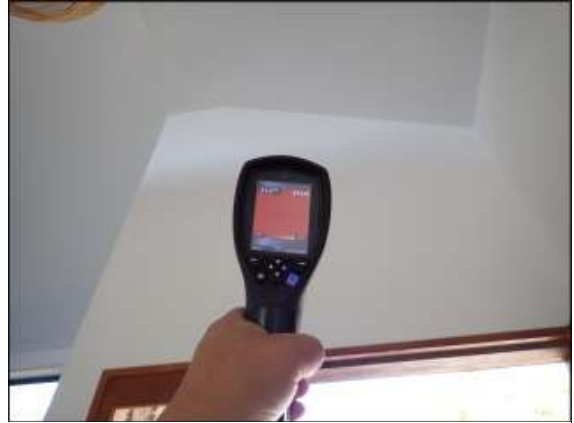
**Photo 25.2** Normal level of moisture reading detected with infrared thermal imaging camera on wall facing exterior at foyer area.

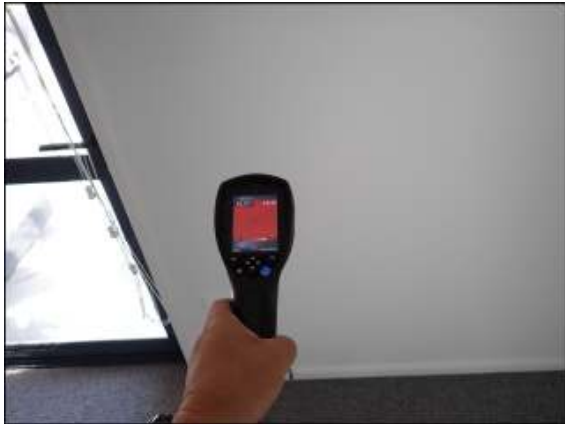
**Photo 25.3** Normal level of moisture reading detected with infrared thermal imaging camera on wall facing exterior in bedroom II.

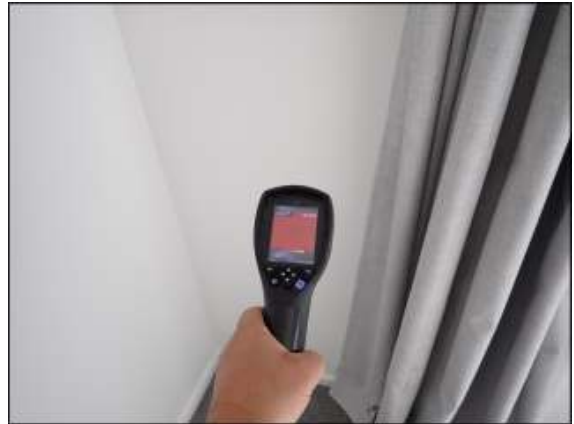
**Photo 25.4** Normal level of moisture reading detected with infrared thermal imaging camera on wall facing exterior in bedroom II.

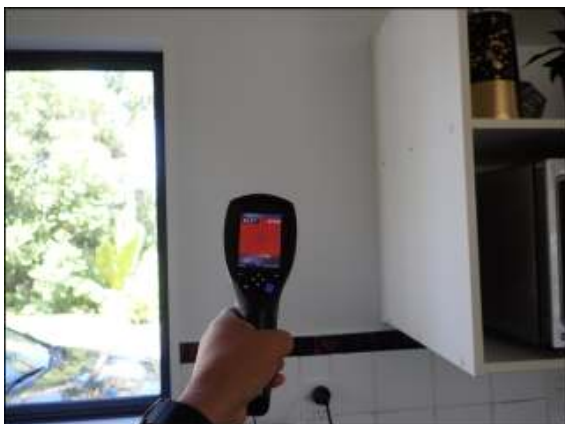
**Photo 25.5** Normal level of moisture reading detected with infrared thermal imaging camera on wall facing exterior at kitchen/dining area.

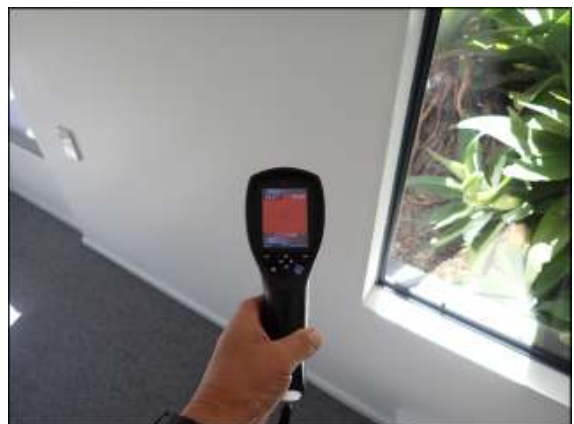
**Photo 25.6** Normal level of moisture reading detected with infrared thermal imaging camera on wall facing exterior at kitchen/dining area.

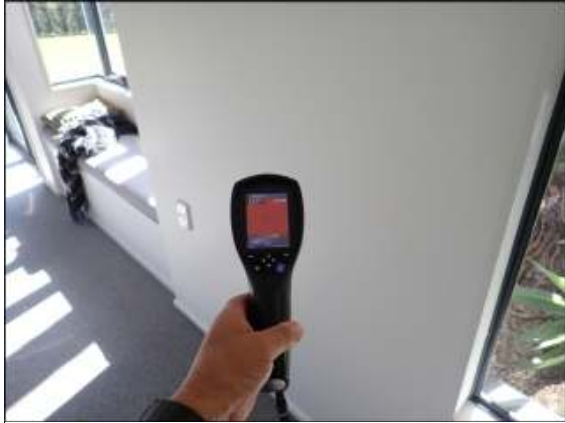
**Photo 26.1** Normal level of moisture reading detected with infrared thermal imaging camera on wall facing exterior around living room.

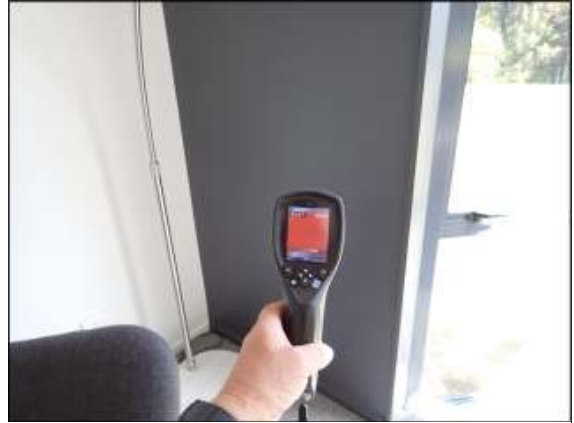
**Photo 26.2** Normal level of moisture reading detected with infrared thermal imaging camera on wall facing exterior around living room.

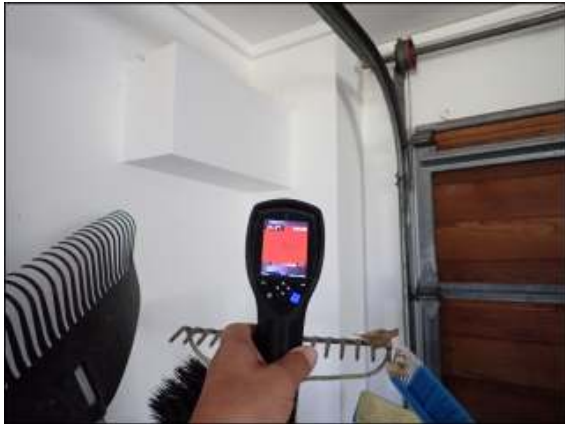
**Photo 26.3** Normal level of moisture reading detected with infrared thermal imaging camera on wall facing exterior in garage.

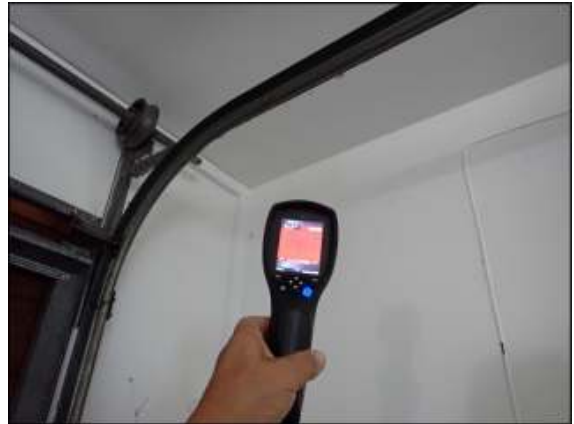
**Photo 26.4** Normal level of moisture reading detected with infrared thermal imaging camera on wall facing exterior in garage.

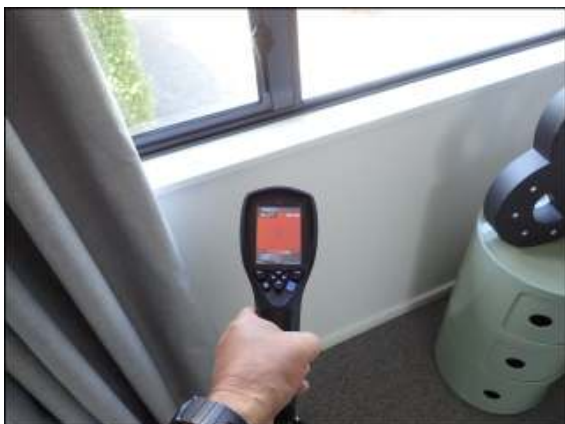
**Photo 26.5** Normal level of moisture reading detected with infrared thermal imaging camera on wall facing exterior in bedroom III.

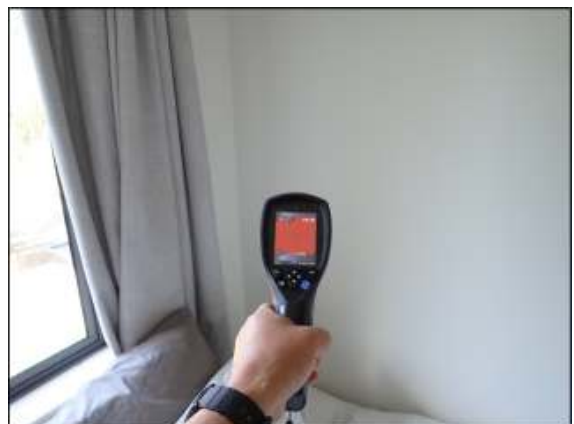
**Photo 26.6** Normal level of moisture reading detected with infrared thermal imaging camera on wall facing exterior in bedroom III.

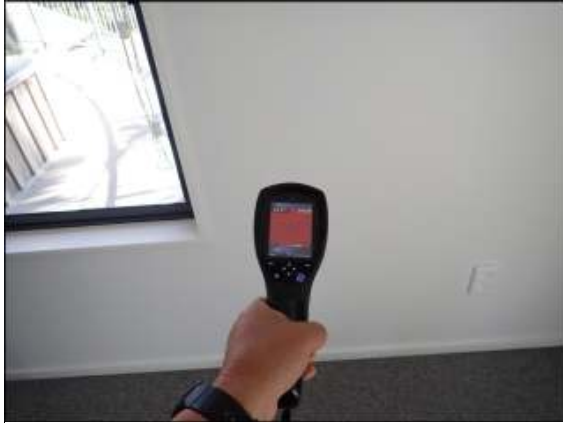
**Photo 27.1** Normal level of moisture reading detected with infrared thermal imaging camera on wall facing exterior in bedroom IV.

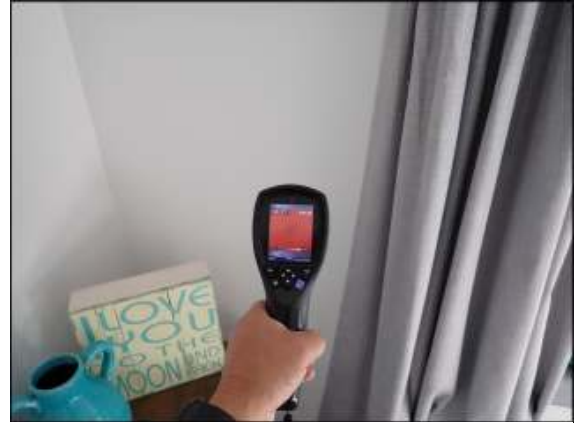
**Photo 27.2** Normal level of moisture reading detected with infrared thermal imaging camera on wall facing exterior in bedroom IV.

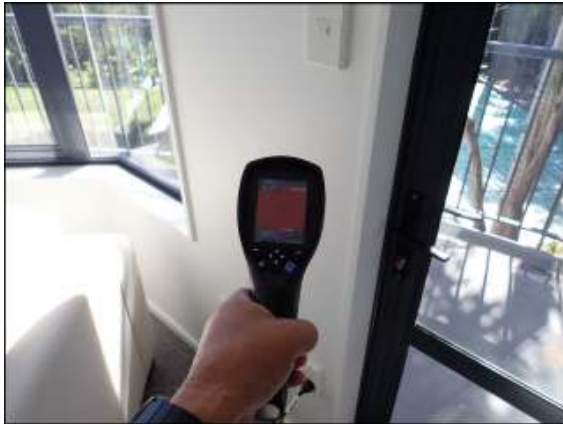
**Photo 27.3** Normal level of moisture reading detected with infrared thermal imaging camera on wall facing exterior in family room.

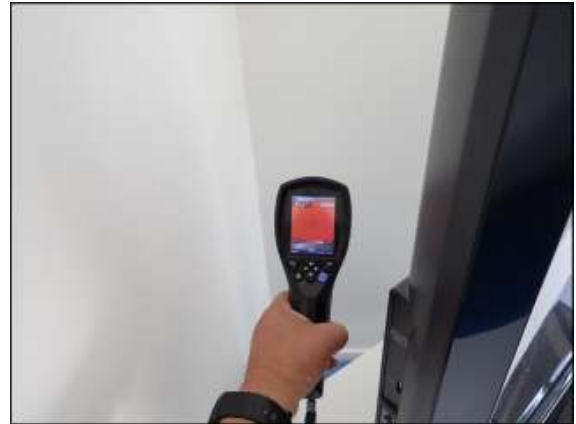
**Photo 27.4** Normal level of moisture reading detected with infrared thermal imaging camera on wall facing exterior in family room.

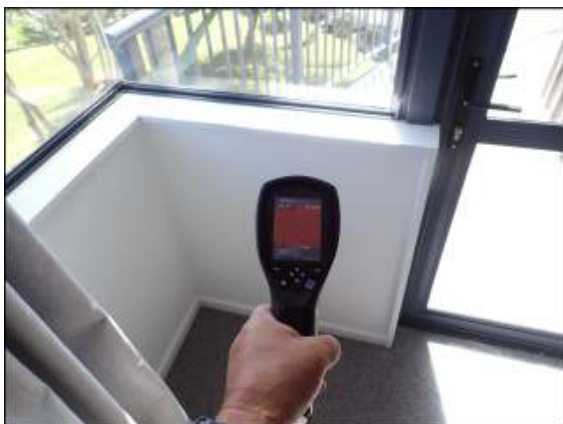
**Photo 27.5** Normal level of moisture reading detected with infrared thermal imaging camera on wall facing exterior in master bedroom.

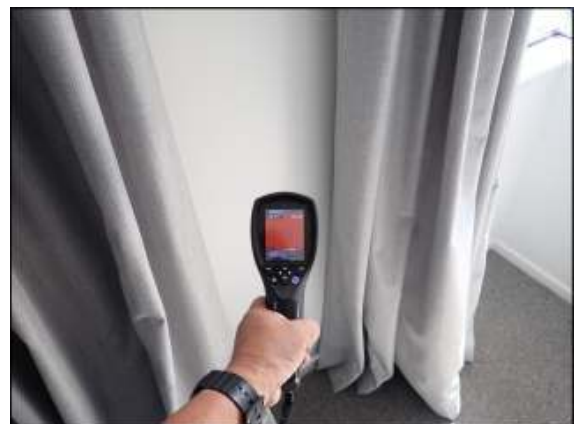
**Photo 27.6** Normal level of moisture reading detected with infrared thermal imaging camera on wall facing exterior in master bedroom.

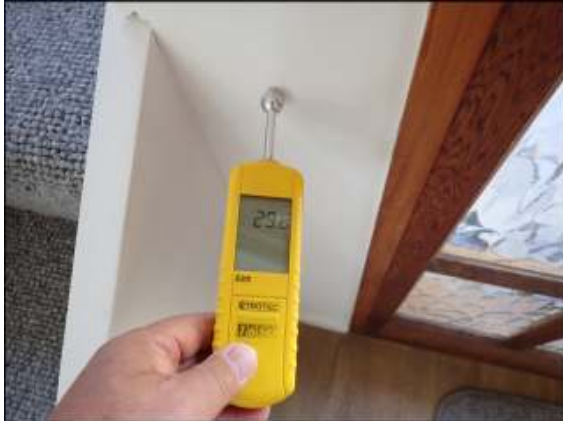
**Photo 28.1** Normal level of moisture detected on wall facing exterior at foyer area. Optimal level shall be between 20 and 40.

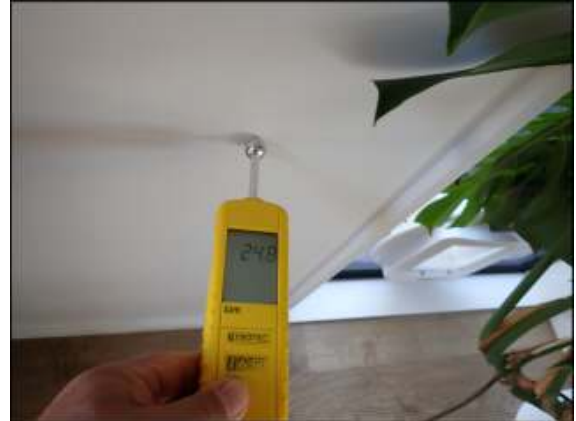
**Photo 28.2** Normal level of moisture detected on wall facing exterior at foyer area. Optimal level shall be between 20 and 40.

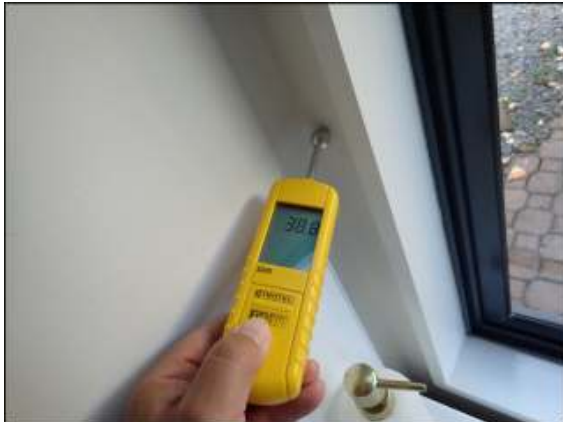
**Photo 28.3** Normal level of moisture detected on wall facing exterior in bedroom II. Optimal level shall be between 20 and 40.

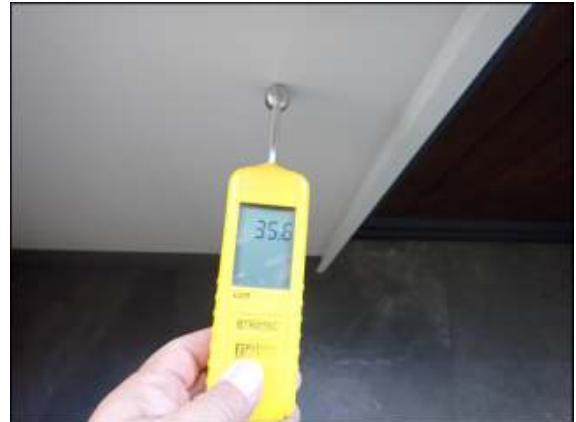
**Photo 28.4** Normal level of moisture detected on wall facing exterior in bedroom II. Optimal level shall be between 20 and 40.

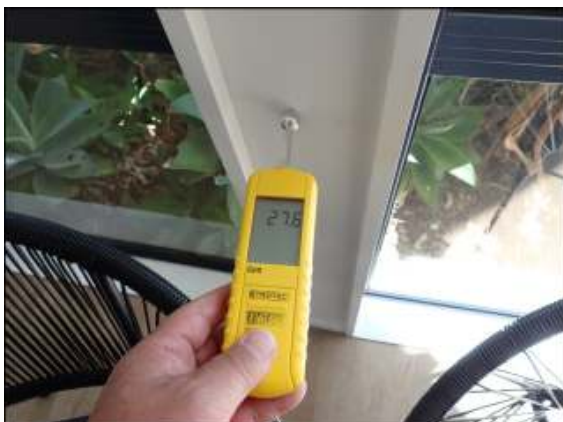
**Photo 28.5** Normal level of moisture detected on wall facing exterior at kitchen/dining area. Optimal level shall be between 20 and 40.

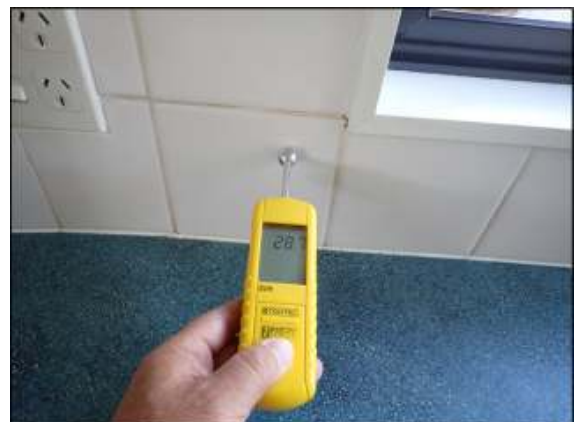
**Photo 28.6** Normal level of moisture detected on wall facing exterior at kitchen/dining area. Optimal level shall be between 20 and 40.

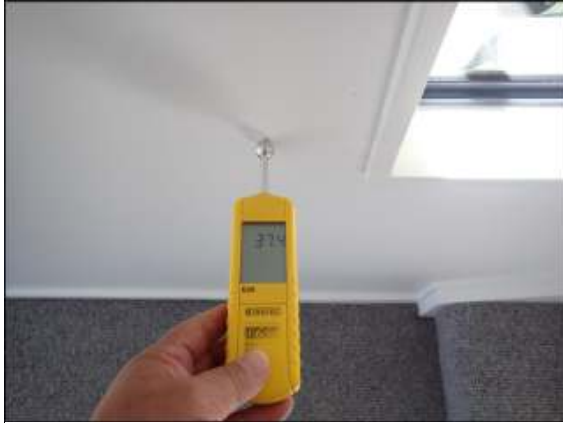
**Photo 29.1** Normal level of moisture detected on wall facing exterior in living room. Optimal level shall be between 20 and 40.

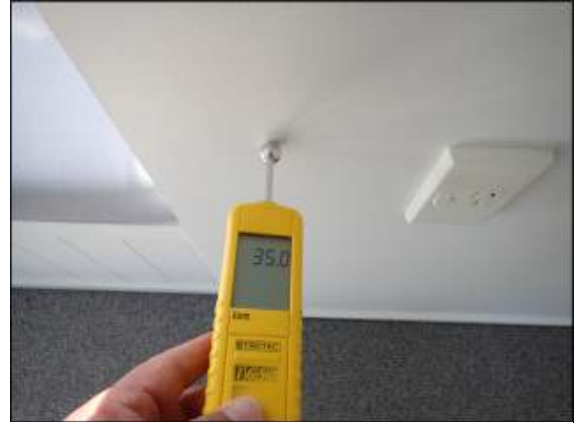
**Photo 29.2** Normal level of moisture detected on wall facing exterior in living room. Optimal level shall be between 20 and 40.

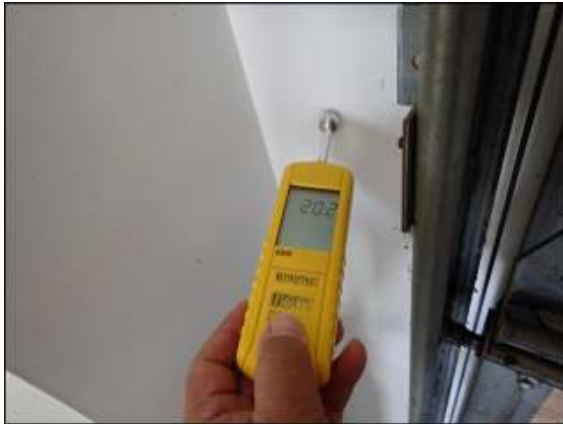
**Photo 29.3** Normal level of moisture detected on wall facing exterior in garage. Optimal level shall be between 20 and 40.

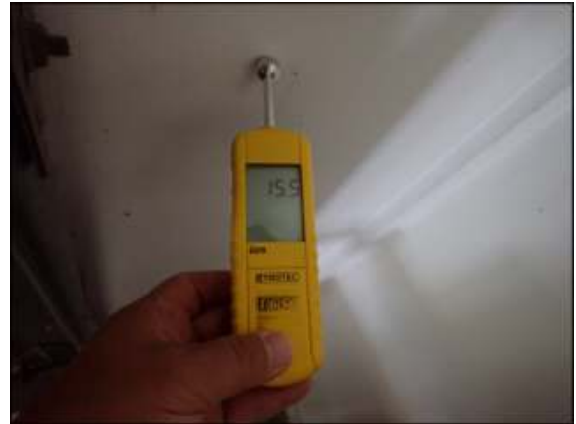
**Photo 29.4** Normal level of moisture detected on wall facing exterior in garage. Optimal level shall be between 20 and 40.

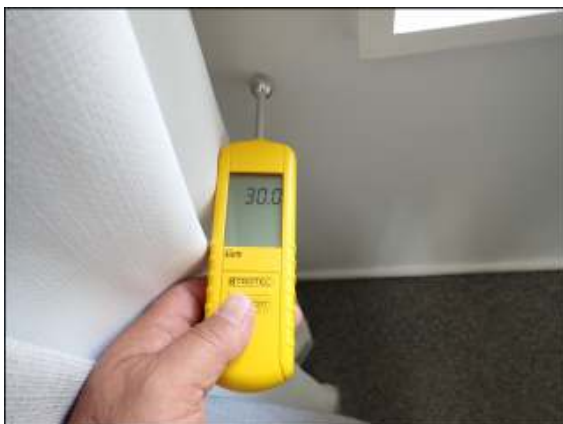
**Photo 29.5** Normal level of moisture detected on wall facing exterior in bedroom III. Optimal level shall be between 20 and 40.

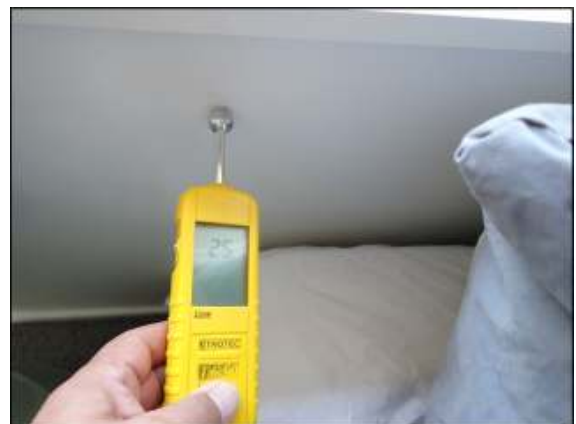
**Photo 29.6** Normal level of moisture detected on wall facing exterior in bedroom III. Optimal level shall be between 20 and 40.

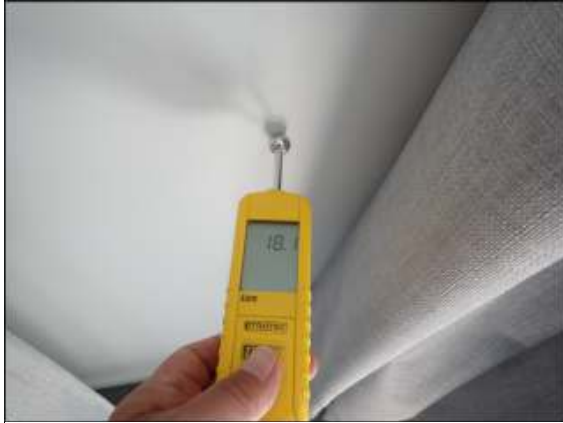
**Photo 30.1** Normal level of moisture detected on wall facing exterior in bedroom IV. Optimal level shall be between 20 and 40.

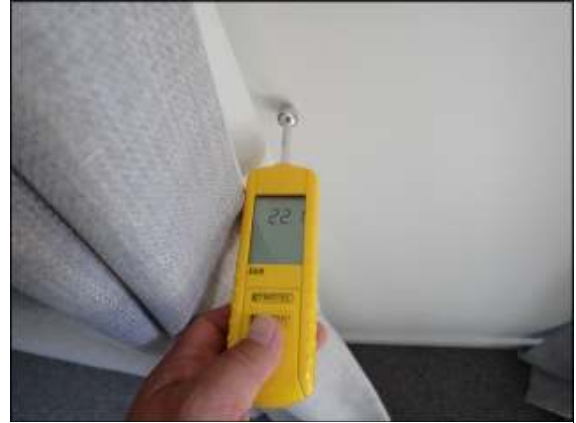
**Photo 30.2** Normal level of moisture detected on wall facing exterior in bedroom IV. Optimal level shall be between 20 and 40.

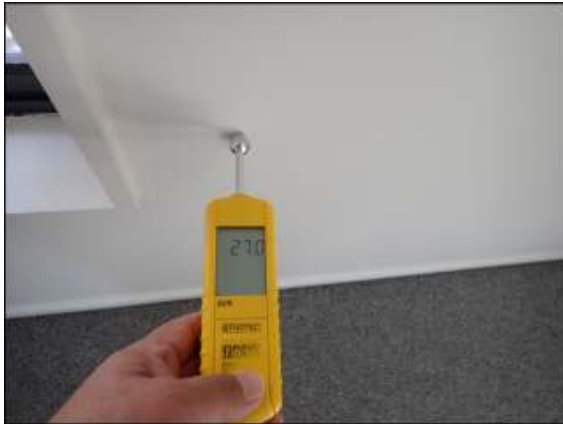
**Photo 30.3** Normal level of moisture detected on wall facing exterior in family room. Optimal level shall be between 20 and 40.

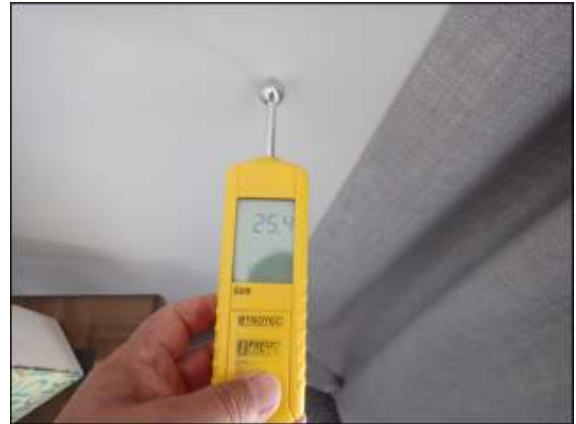
**Photo 30.4** Normal level of moisture detected on wall facing exterior in family room. Optimal level shall be between 20 and 40.

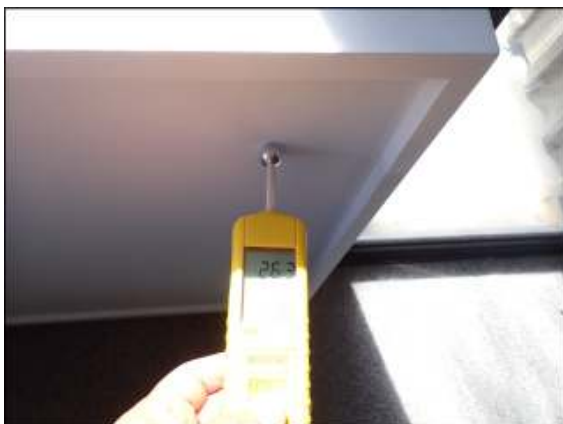
**Photo 30.5** Normal level of moisture detected on wall facing exterior in master bedroom. Optimal level shall be between 20 and 40.

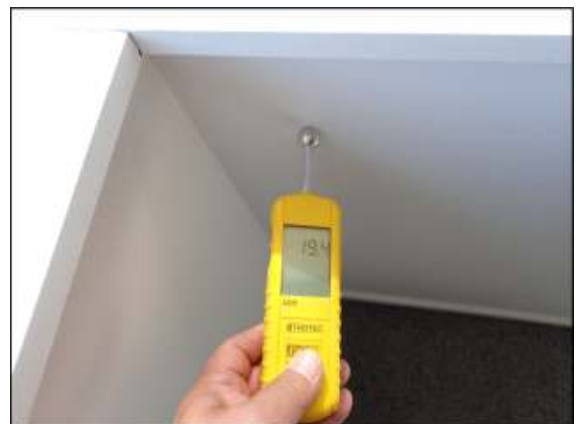
**Photo 30.6** Normal level of moisture detected on wall facing exterior in master bedroom. Optimal level shall be between 20 and 40.

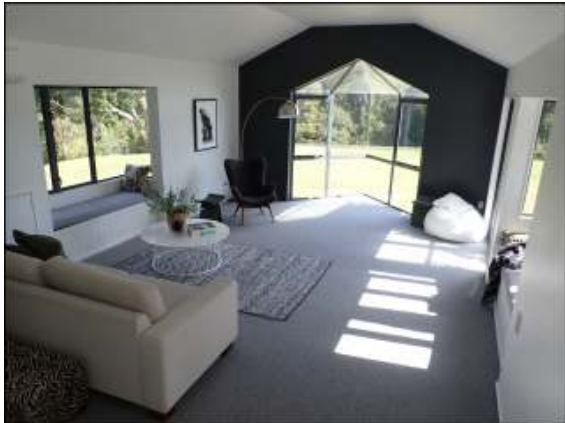
Living room on carpet floor appeared in good condition without damage or buckling noticed.  
No evidence of leaky condition noticed.

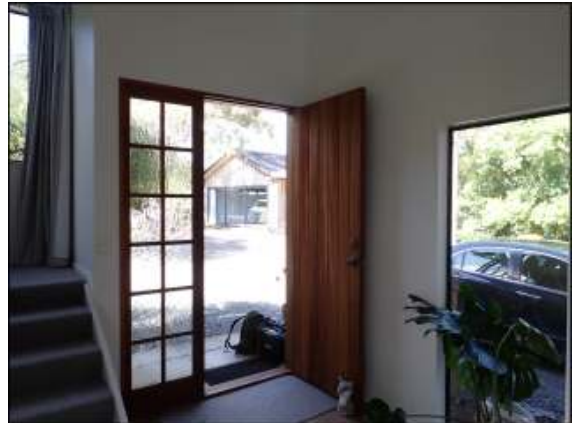
Foyer area on timber flooring appeared in good condition without damage or buckling noticed.  
No evidence of leaky condition noticed.

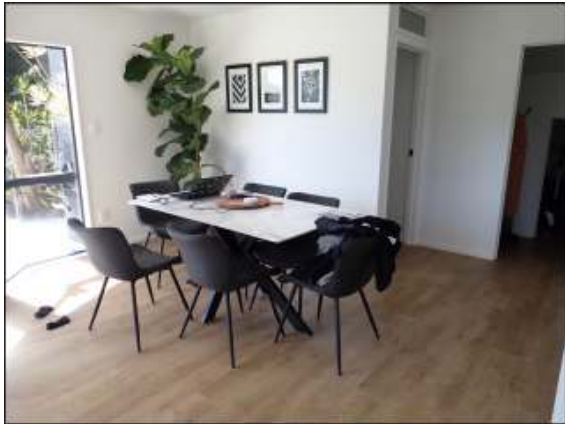
Dining area on timber flooring appeared in good condition without damage or buckling noticed.  
No evidence of leaky condition noticed.

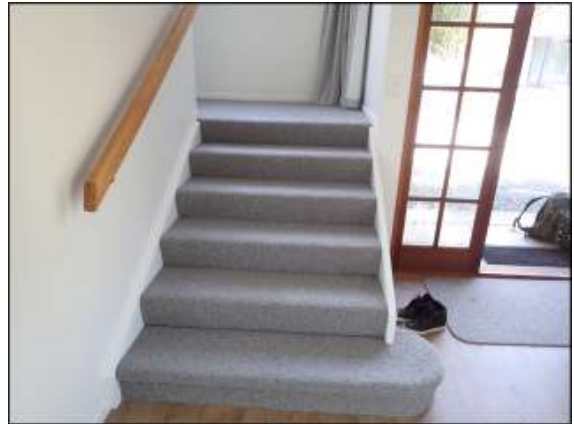
Stairs on carpet floor secured with timber handrail appeared in good condition without damage or buckling noticed. No evidence of leaky condition noticed.

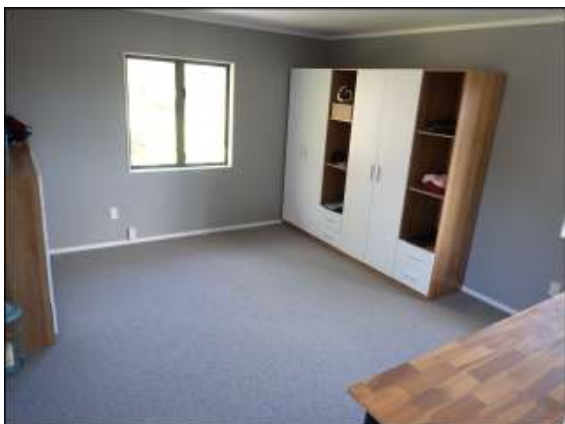
Studio at mezzanine on carpet floor appeared in good condition without damage or buckling.  
No evidence of leaky condition noticed.

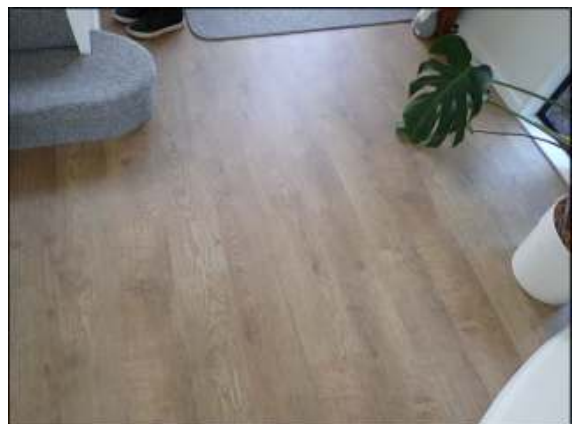
Hallway on timber flooring appeared in good condition without damage or buckling noticed.

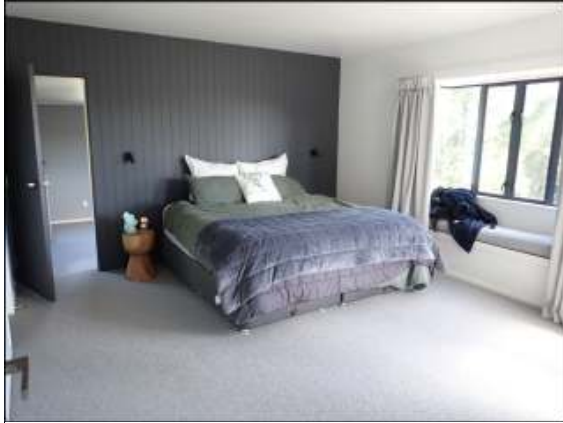
Master bedroom on carpet floor appeared in good condition. No damage or buckling noticed.  
No evidence of leaky condition noticed.

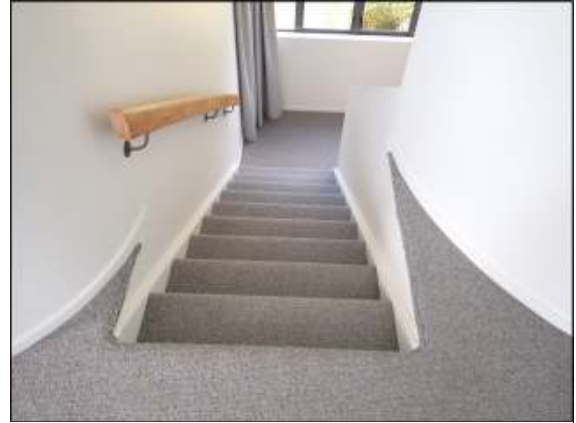
Stairs on carpet floor secured with timber handrail appeared in good condition without damage or buckling noticed. No evidence of leaky condition noticed.
