# STANDARD HOUSE INSPECTION

For the Property Located At:

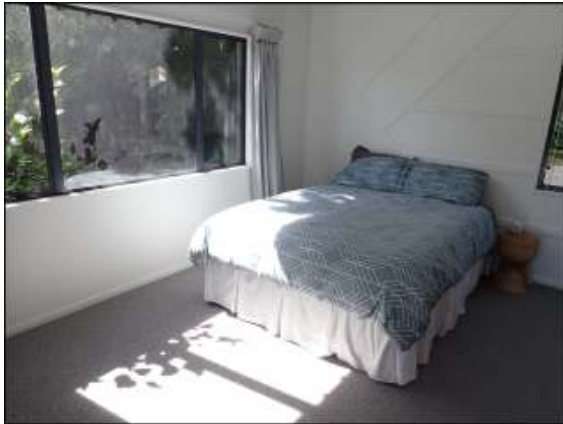
Bedroom II on carpet floor appeared in good condition. No damage or buckling noticed.  
No evidence of leaky condition noticed.

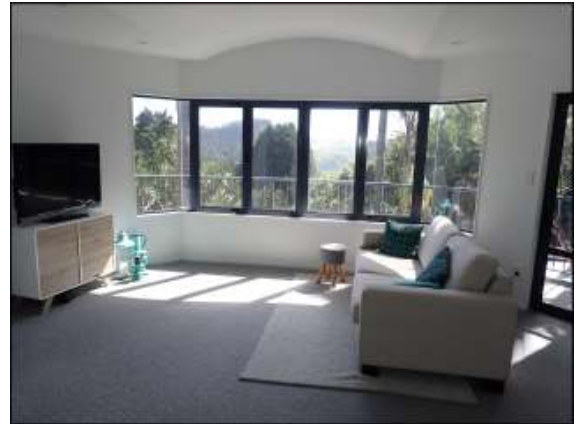
Family room on carpet floor appeared in good condition. No damage or buckling noticed.  
No evidence of leaky condition noticed.

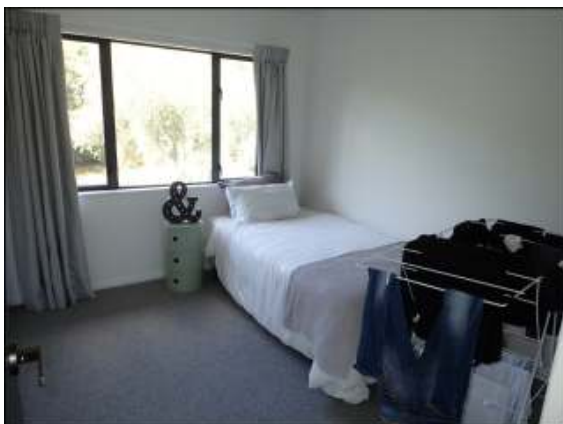
Bedroom III on timber flooring appeared in good condition. No damage or buckling noticed.  
No evidence of leaky condition noticed.

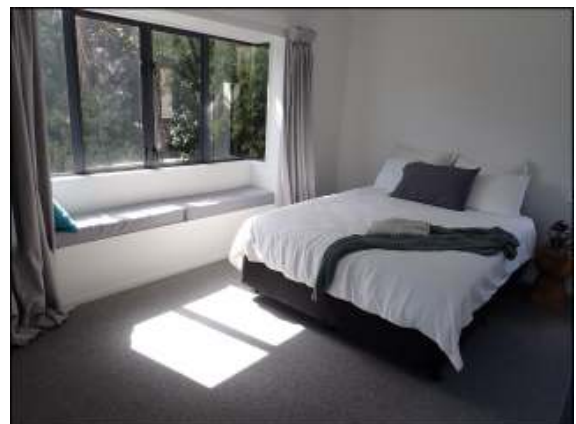
Bedroom IV on carpet floor appeared in good condition. No damage or buckling noticed.  
No evidence of leaky condition noticed.

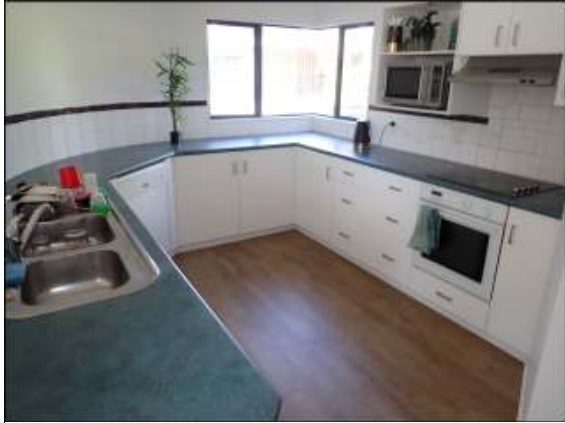
Kitchen area on timber flooring appeared in good condition without damage or buckling noticed.

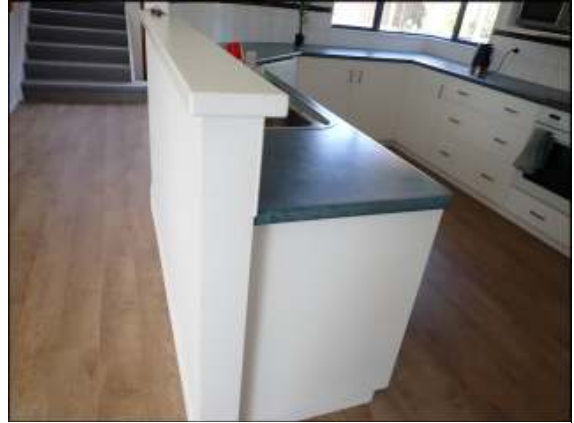
Extended work bench and breakfast table appeared in good condition without damage.

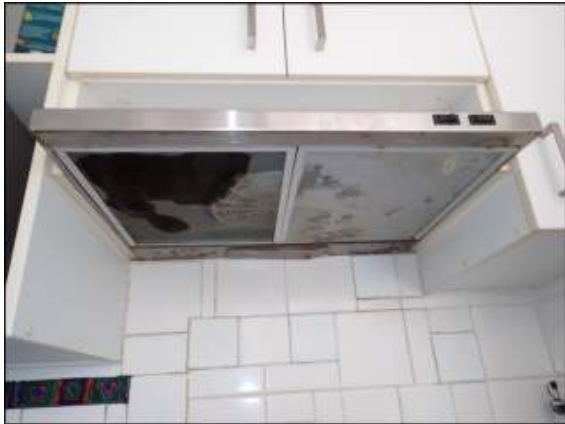
Ventilation fan and lighting fixture above cook top. Operation was not tested.

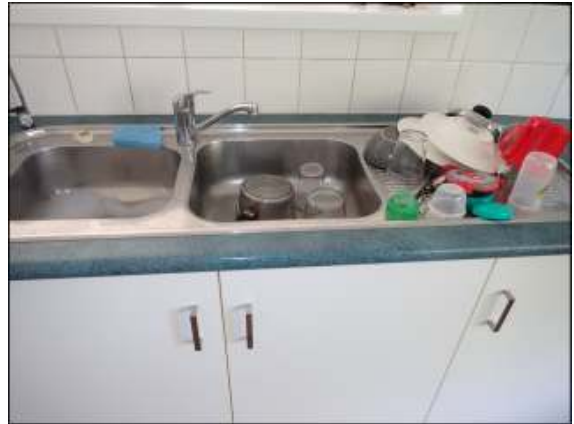
Stainless steel sink secured on work bench appeared in good condition.

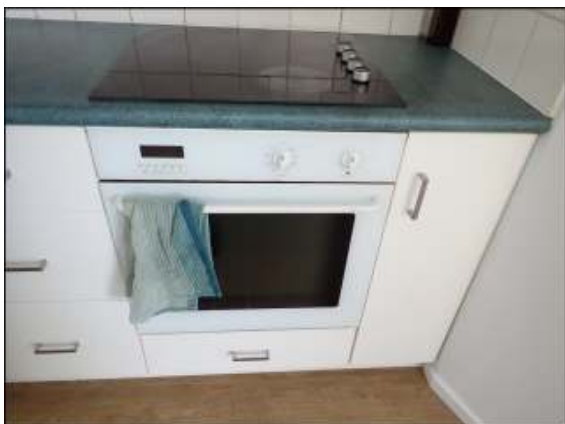
Electric cook top and oven appeared in good condition. Operation was not tested.

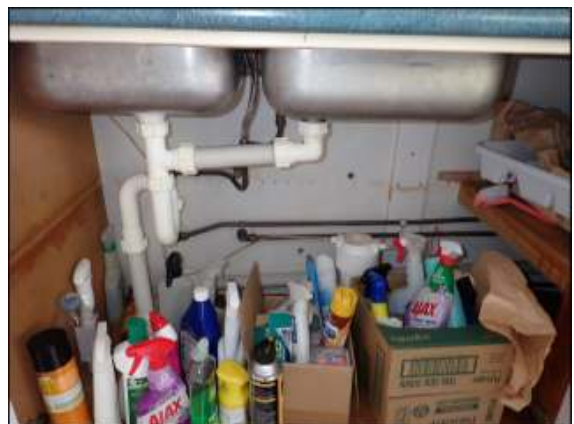
U-trap without garbage dispense appeared in good condition without damage noticed.

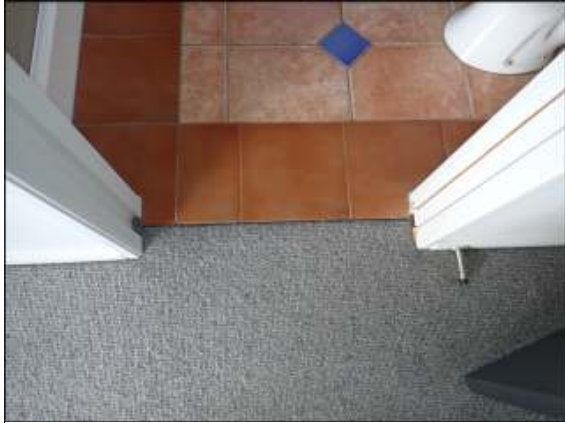
Floor material change from carpet to tile at en suite bathroom appeared in good condition. No crack or damage noticed.

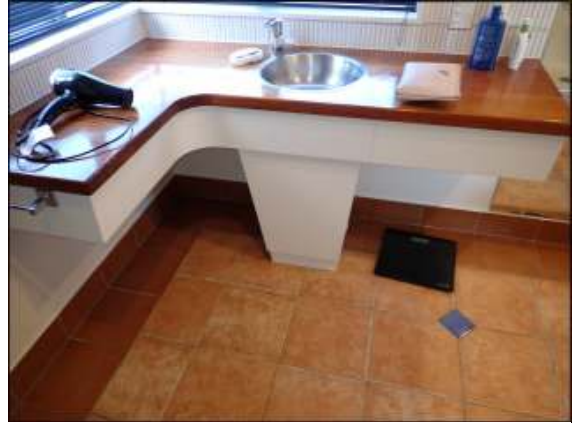
Hand wash basin and vanity appeared in good condition without crack or damage.

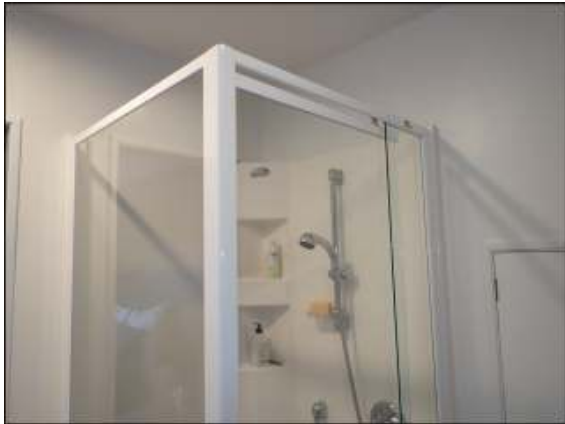
Prefabricated shower stall appeared in good condition without damage and anomaly noticed.

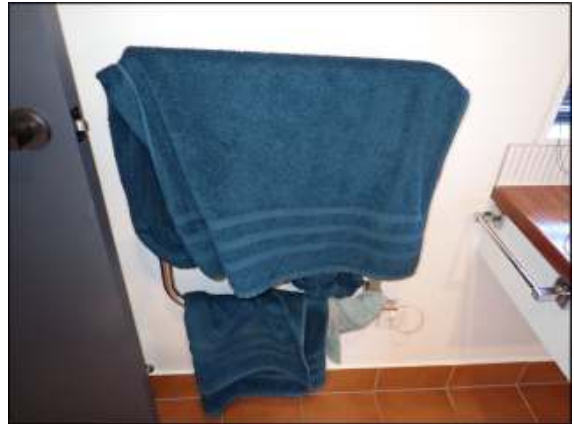
Electric towel dry hanger secured on wall. Operation was tested and working OK.

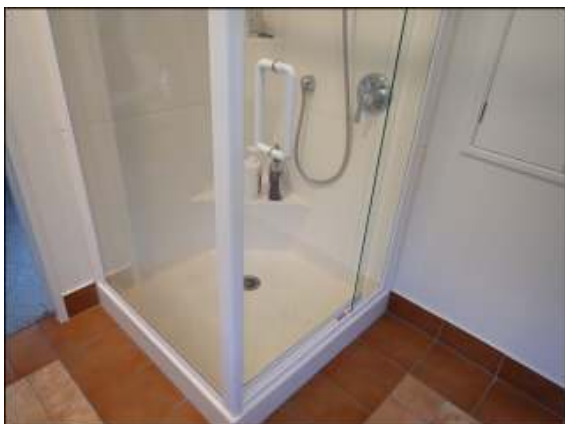
Prefabricated shower stall appeared in good condition. Normal level of moisture detected around stall.

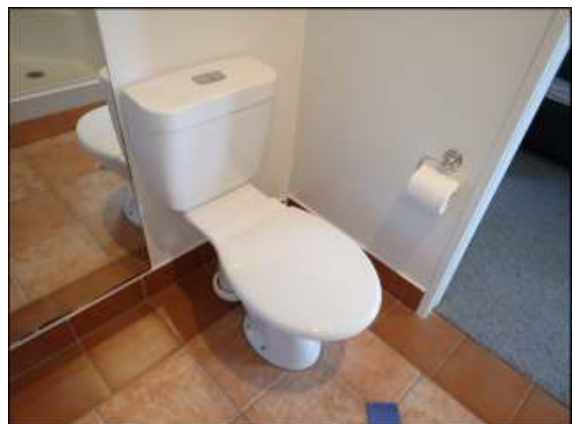
Ceramic toilet secured on floor without damage or dislocation was noticed. Normal level of moisture detected around toilet.

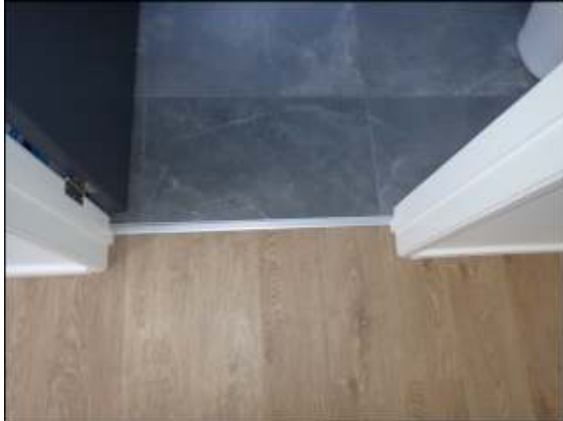
Floor material change from timber flooring to tile in bathroom appeared in good condition. No crack or damage noticed.

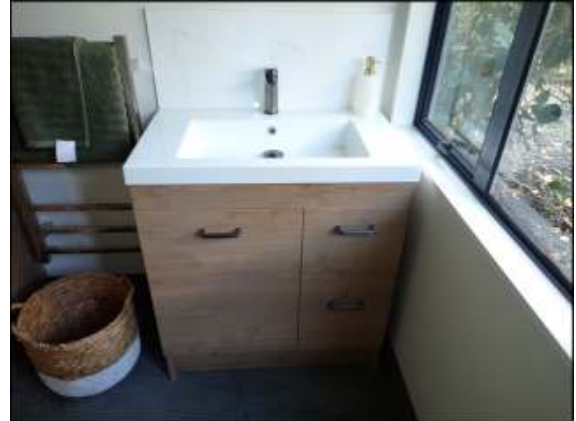
Hand wash basin and vanity appeared in good condition without crack or damage.

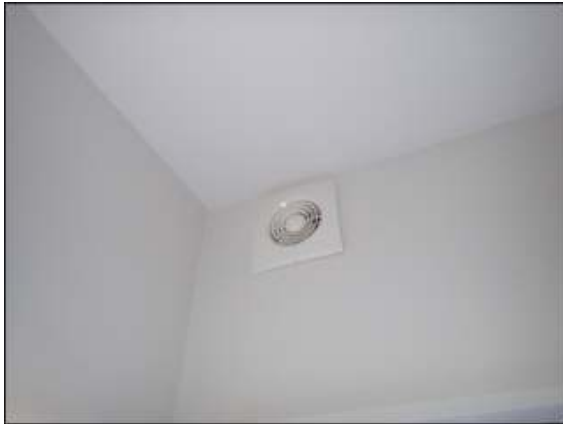
Lighting fixture and ventilation fan on wall. Operation was tested and working OK.

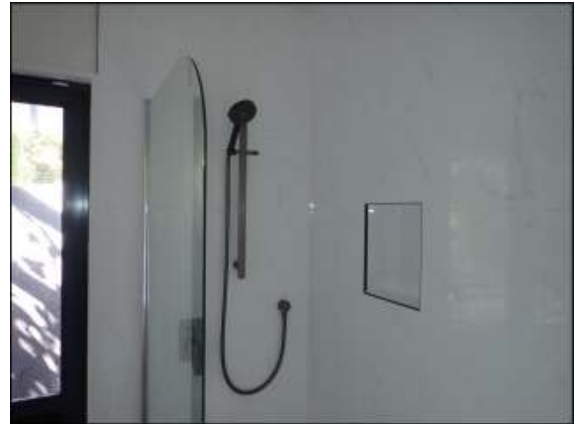
Built-in on wall shower appeared in good condition. No damage or anomaly noticed.

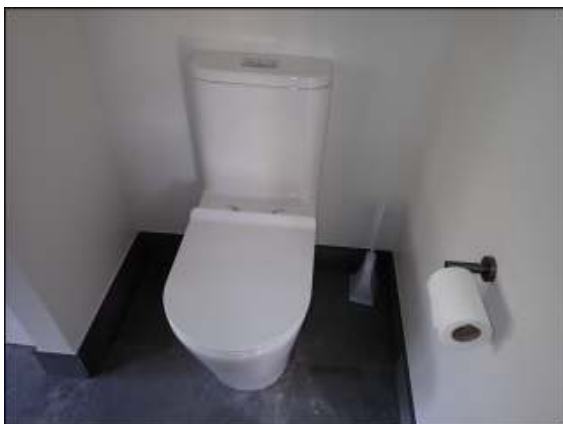
Ceramic toilet secured on floor without damage or dislocation was noticed. Normal level of moisture detected around toilet.

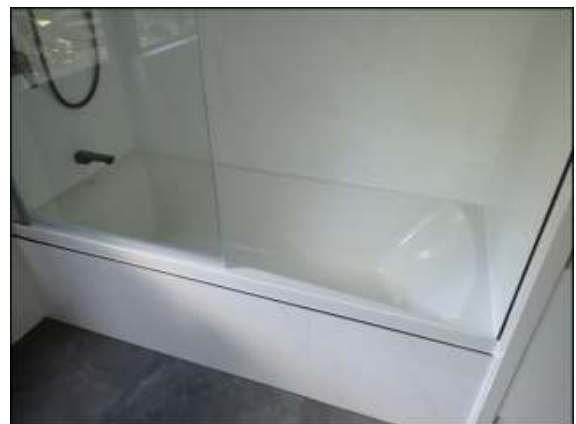
Acrylic bathtub secured on floor without damage or dislocation was noticed. Normal level of moisture detected around tub.

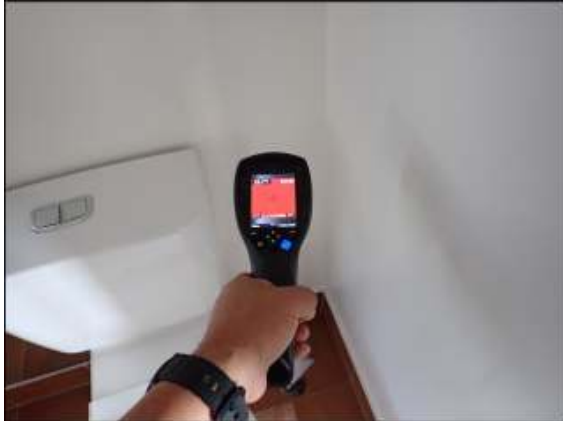
Normal level of moisture reading with infrared thermal imaging camera on wall around toilet.

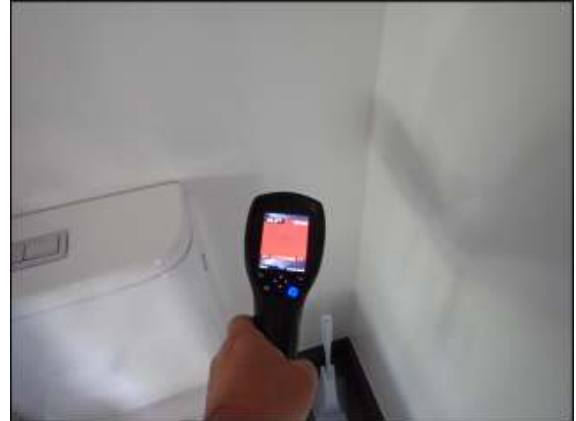
Normal level of moisture reading with infrared thermal imaging camera on wall around toilet.

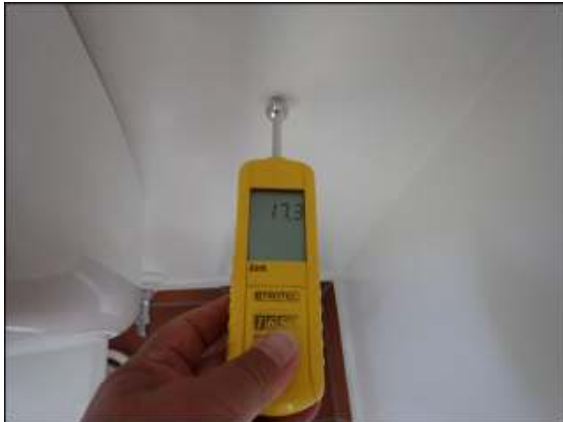
Normal level of moisture detected on wall around toilet. Optimal level shall be between 20 and 40.

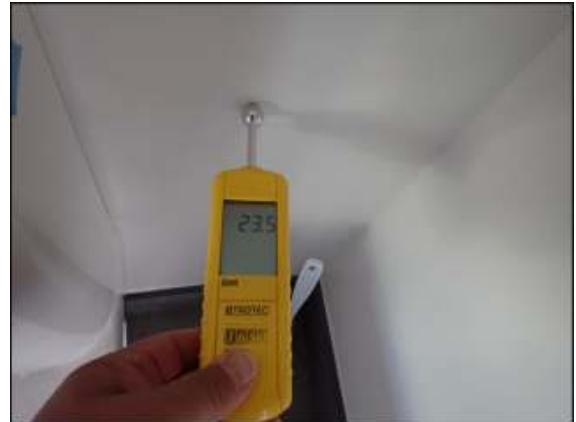
Normal level of moisture detected on wall around toilet. Optimal level shall be between 20 and 40.

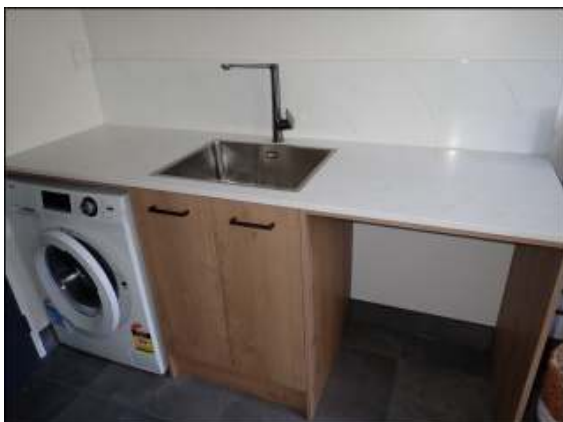
Laundry area appeared in good condition. Normal level of moisture detected on wall around laundry area.

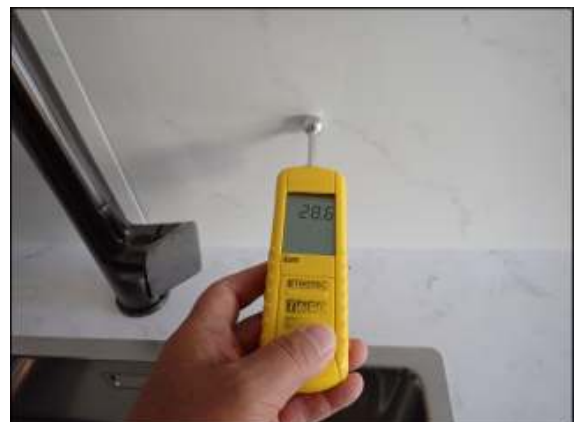
Normal level of moisture detected on wall around laundry connection. Optimal level shall be between 20 and 40.
